Manhole Inspection Summary

Manhole # S27Q__007MH

Insp Date: **7/6/09 1:16 PM**

Location Address: **1201 Wicomico St.**

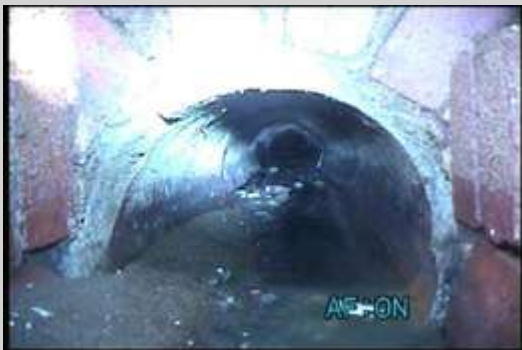
12 O'Clock Outflow

Pipe Height: **6** (in.) Rod and Bar (Angled)
Pipe Material: **Clay** ☐ Pipe Lined
Invert Depth: **8.46** (ft.) Flow Characteristics: **None**
Deposits: ☒ None ☐ Mud ☐ Sludge ☐ Debris ☐ Grease
Silt Depth: **0** (in.) Deposits Extent:
Infiltration: **None** Pipe Seal Cond: **Sound**

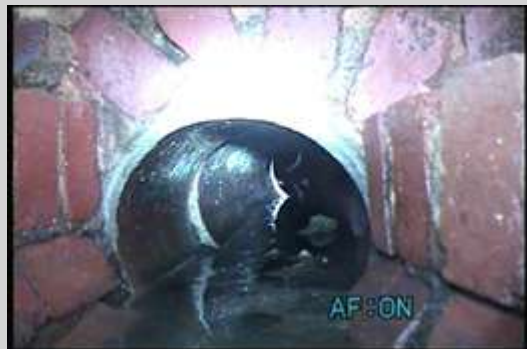
8 O'Clock Inflow

Pipe Height: **6** (in.) Rod and Bar (Angled)

Pipe Material: **Clay** ☐ Pipe Lined

Infiltration: **None**
